THE
GREAT EARTHQUAKE
OF JAPAN

1891.

BY
JOHN MILNE.
AND
W.K. BURTON.
PLATES BY K. OGAWA.

JOHN MILNE, F.R.S. PROFESSOR OF MINING AND GEOLOGY ; IMPERIAL UNIVERSITY OF JAPAN,

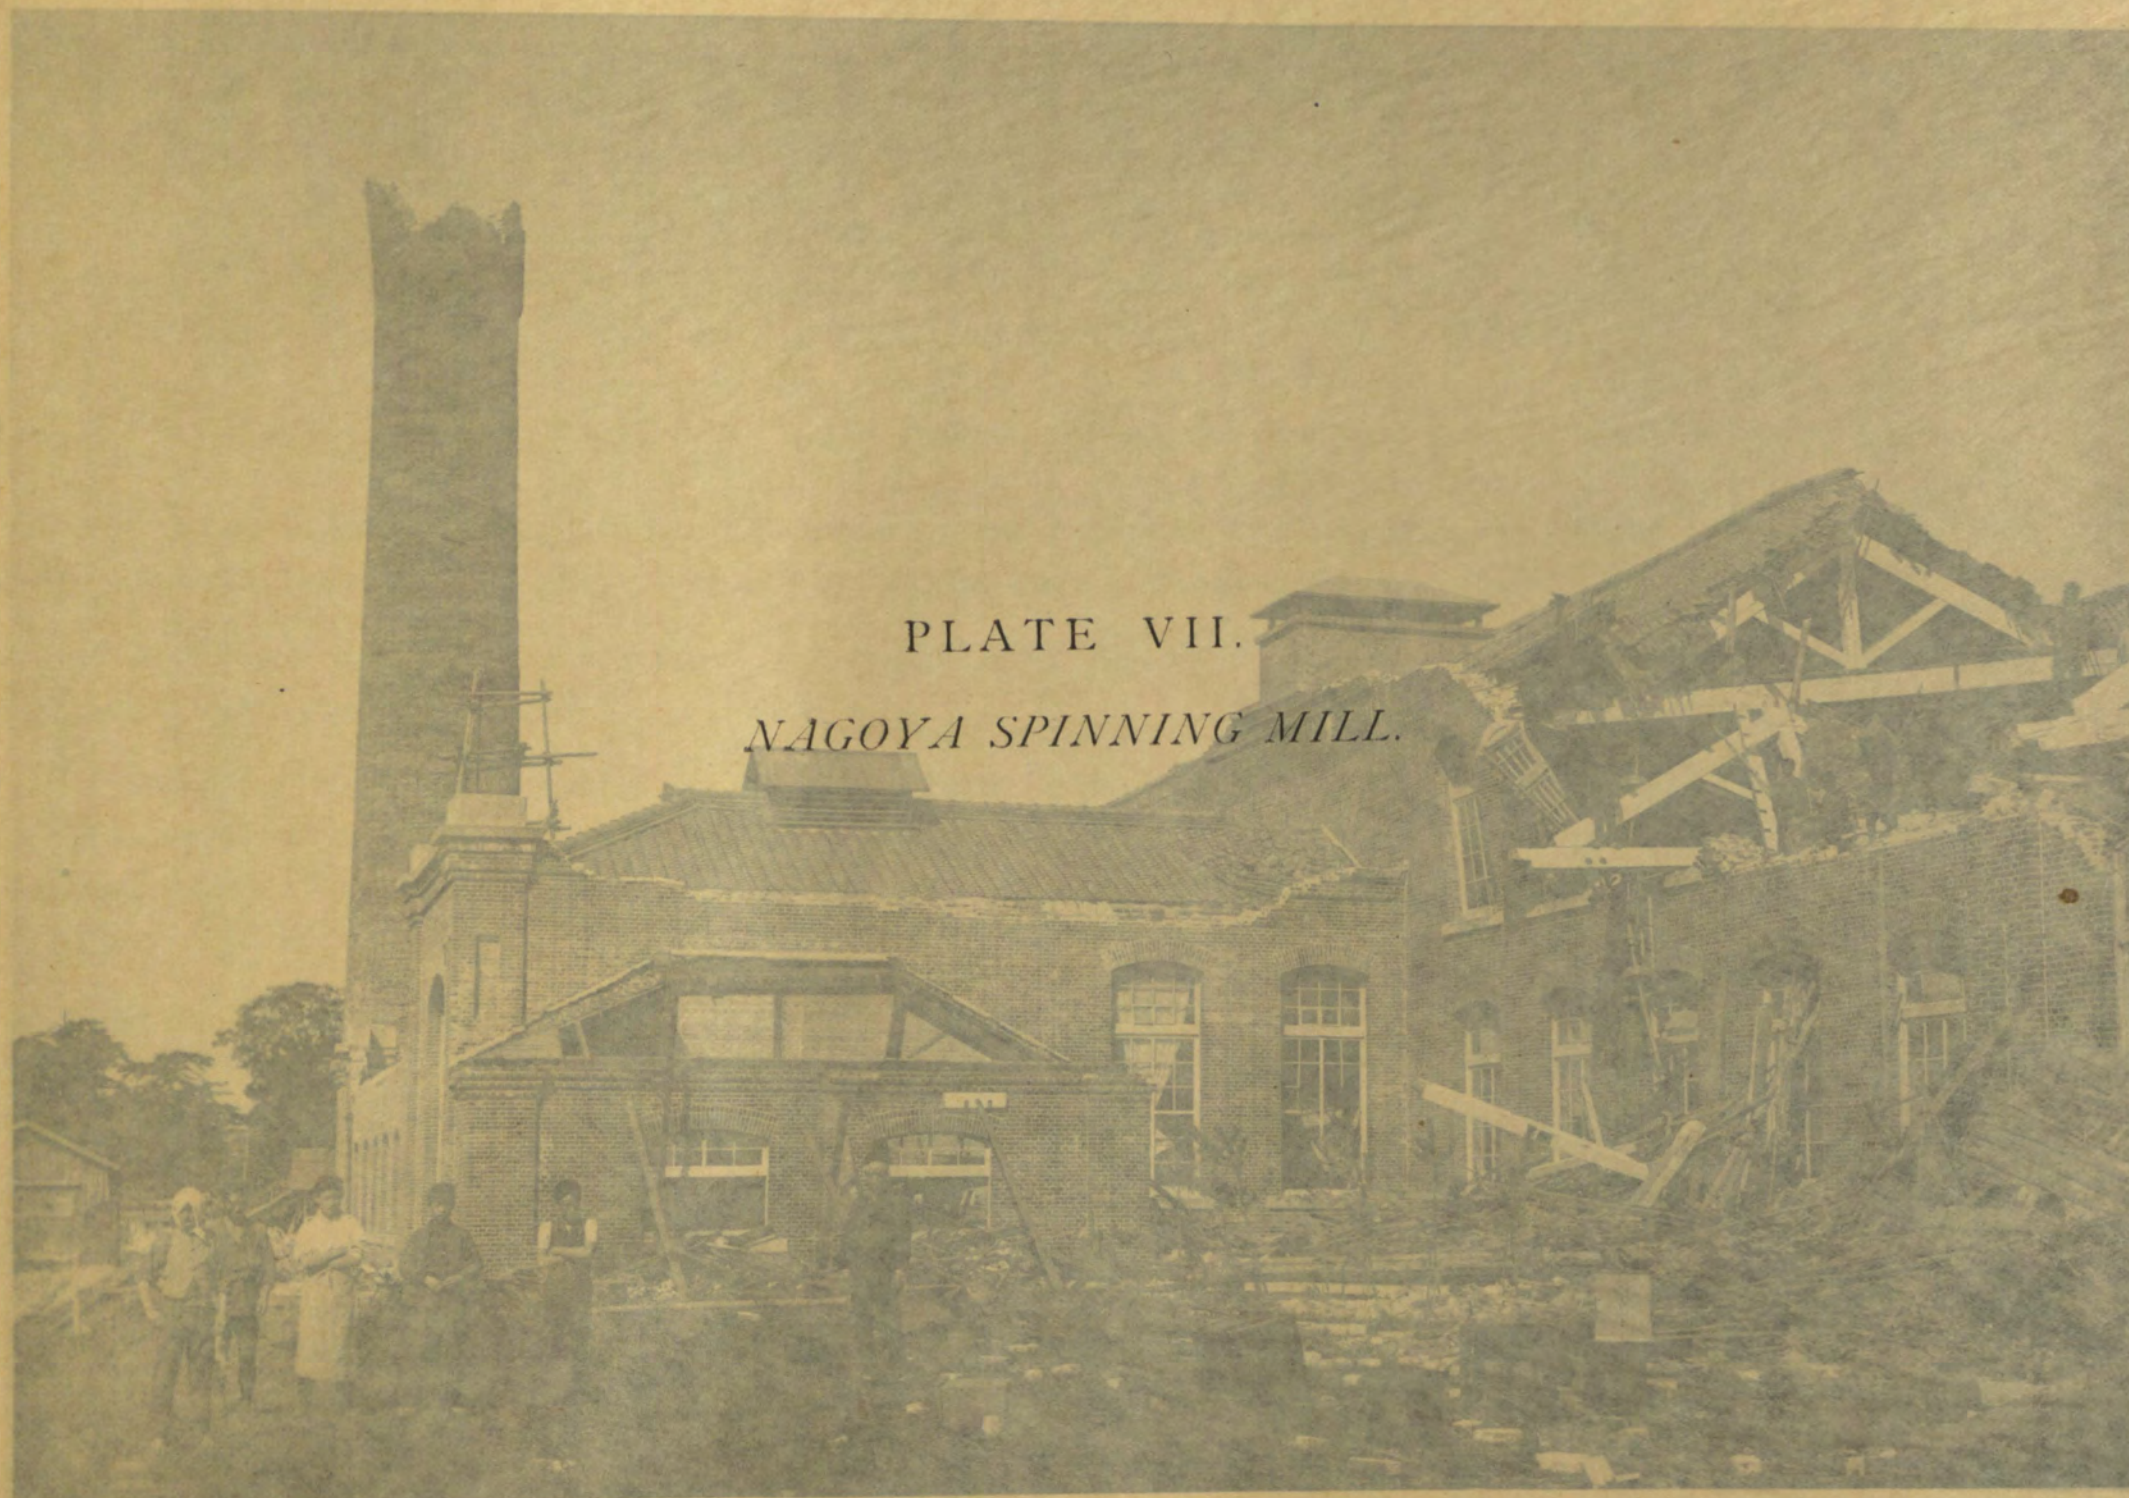
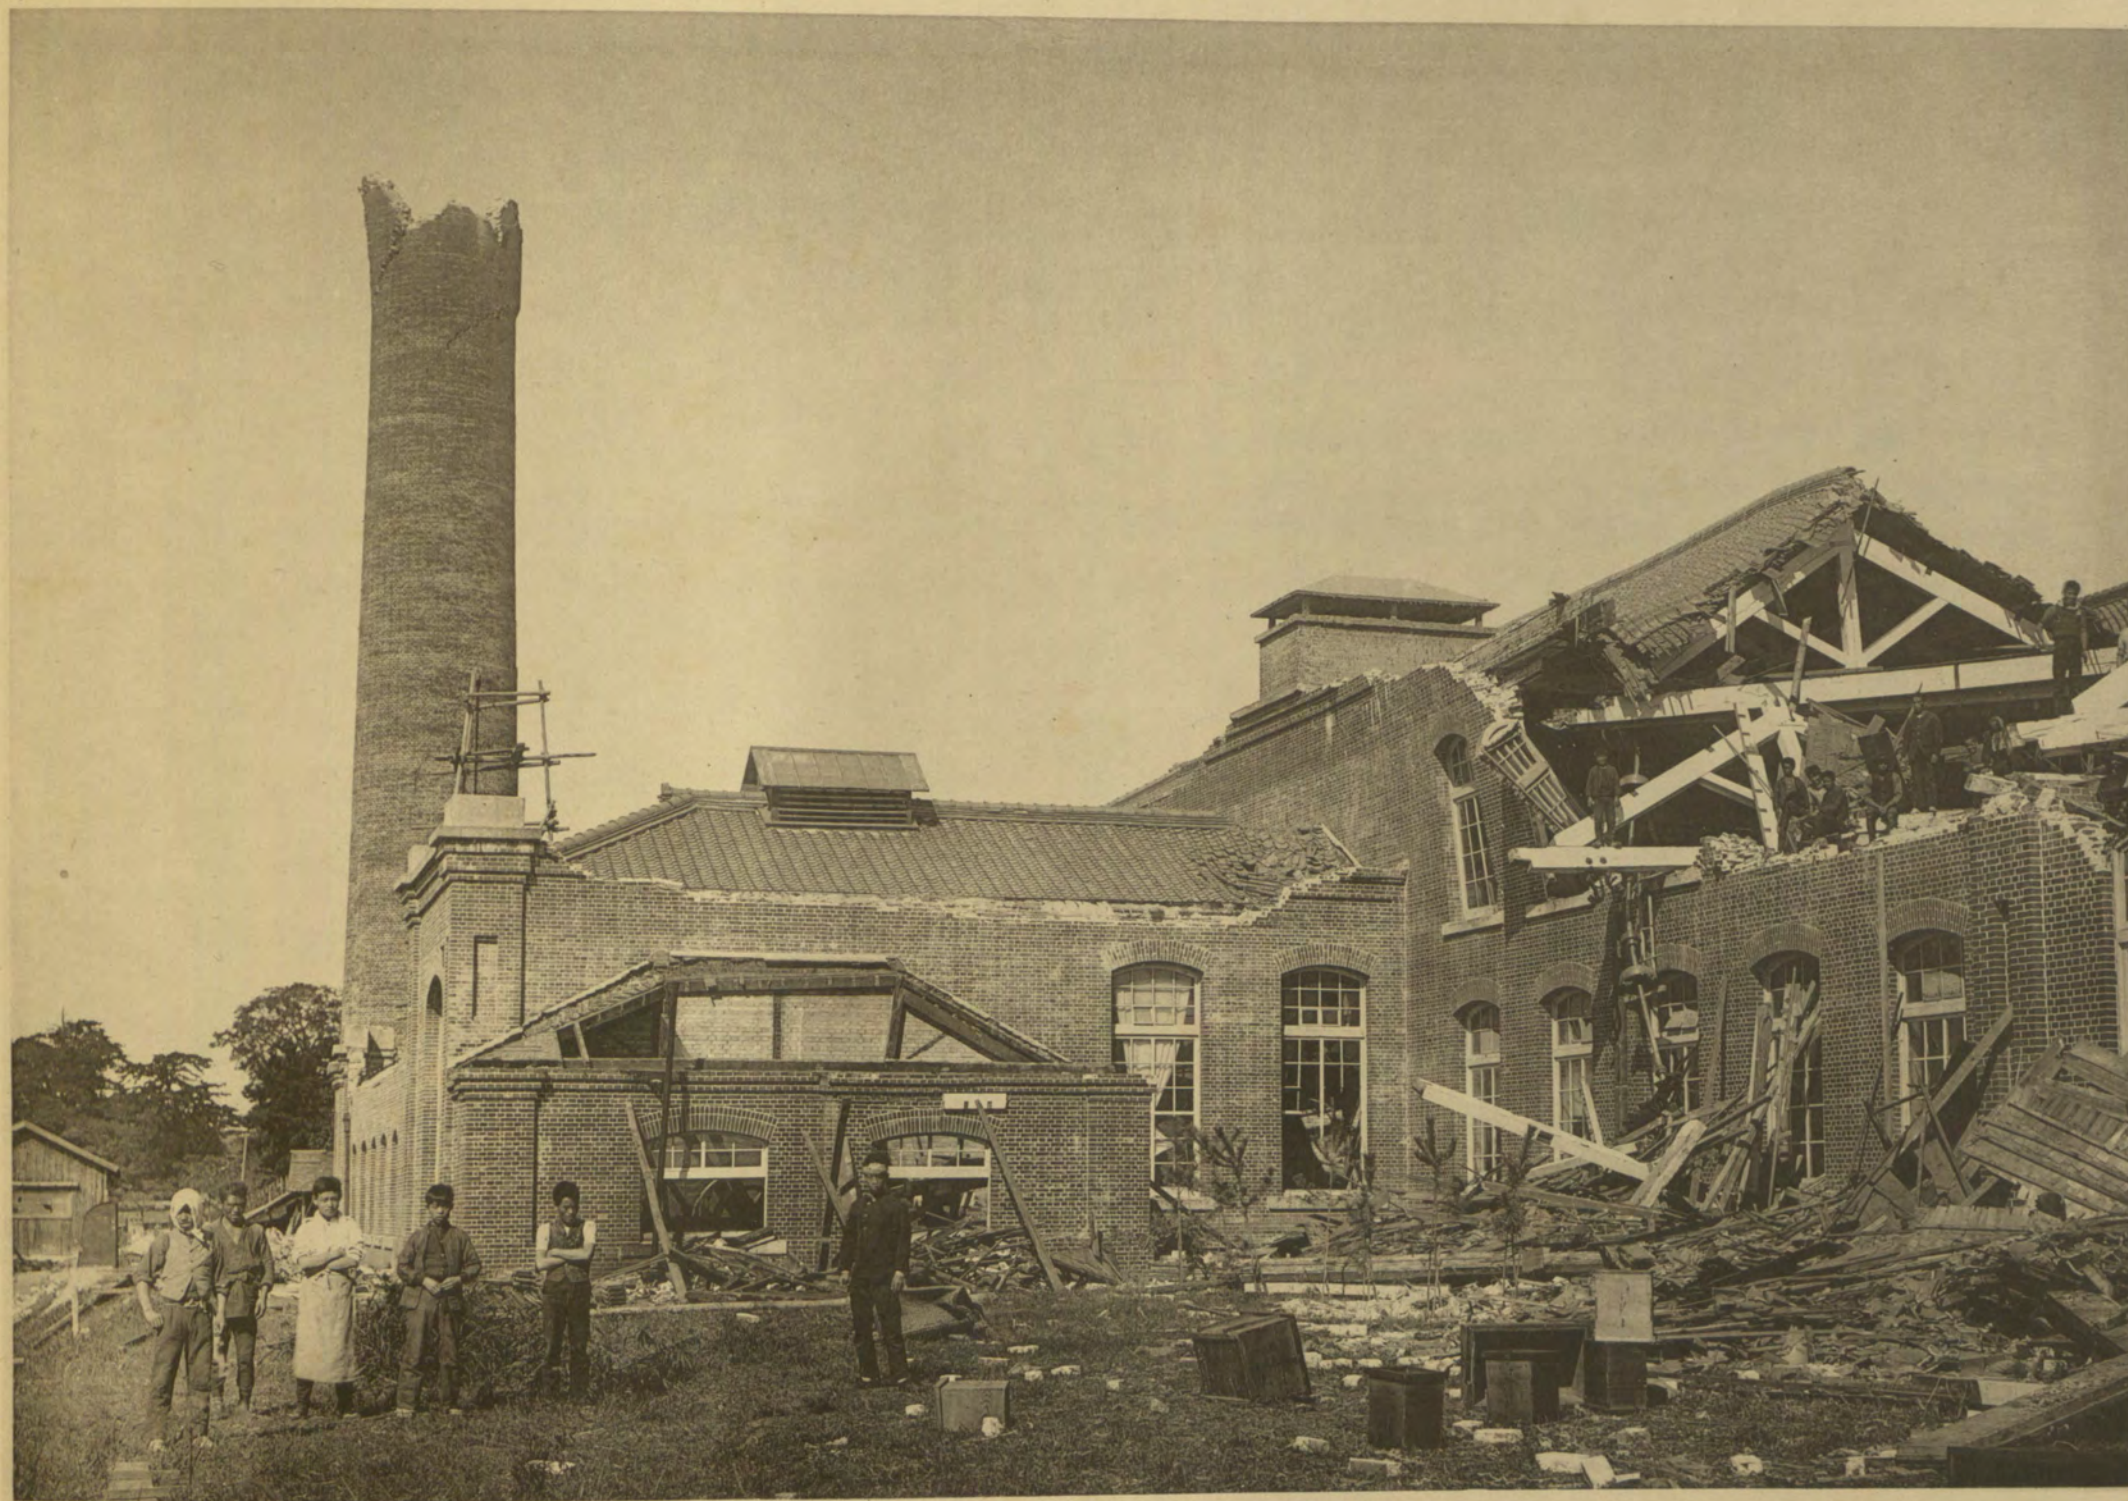
PLATE VII.

It is notable that the Earthquake was not particularly severe at the Spinning Mill, Japanese houses near it not having been much damaged.

The broken chimney, which was evidently snapped in two,—much as we might snap a light fishing-rod by a sudden jerk,—presents an appearance similar to that of the chimneys which were destroyed in Tokyo, Yokohama, and other places.

One observer describes how he saw a chimney sway from side to side, then crack, apparently separate, and then, after one or two swings more, it toppled over.

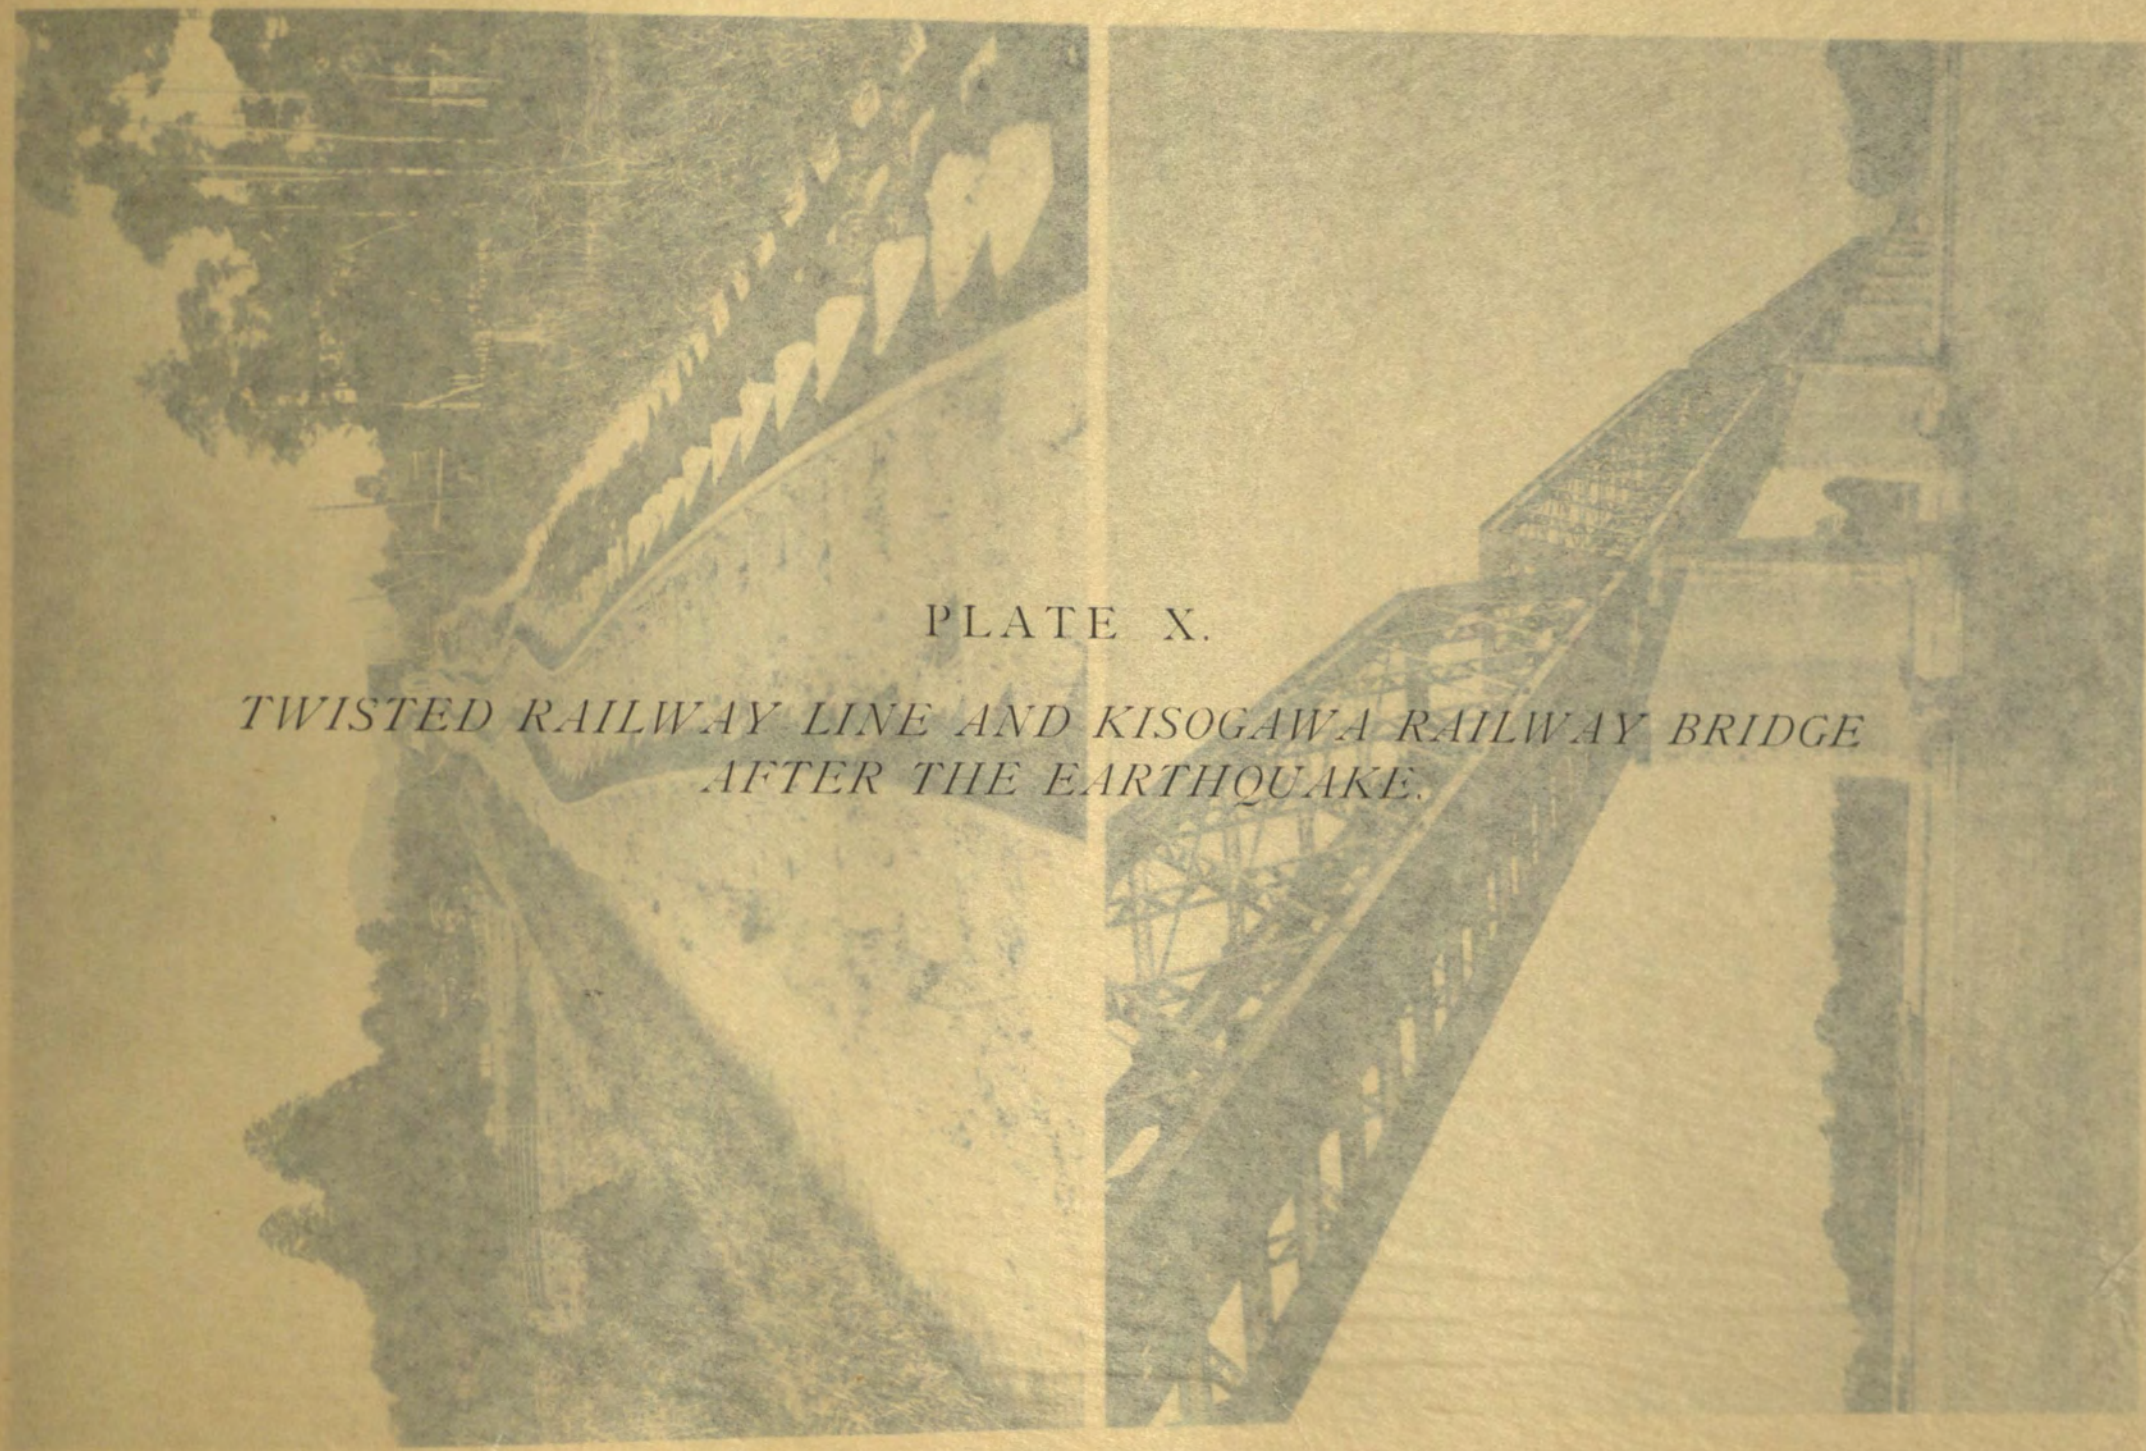
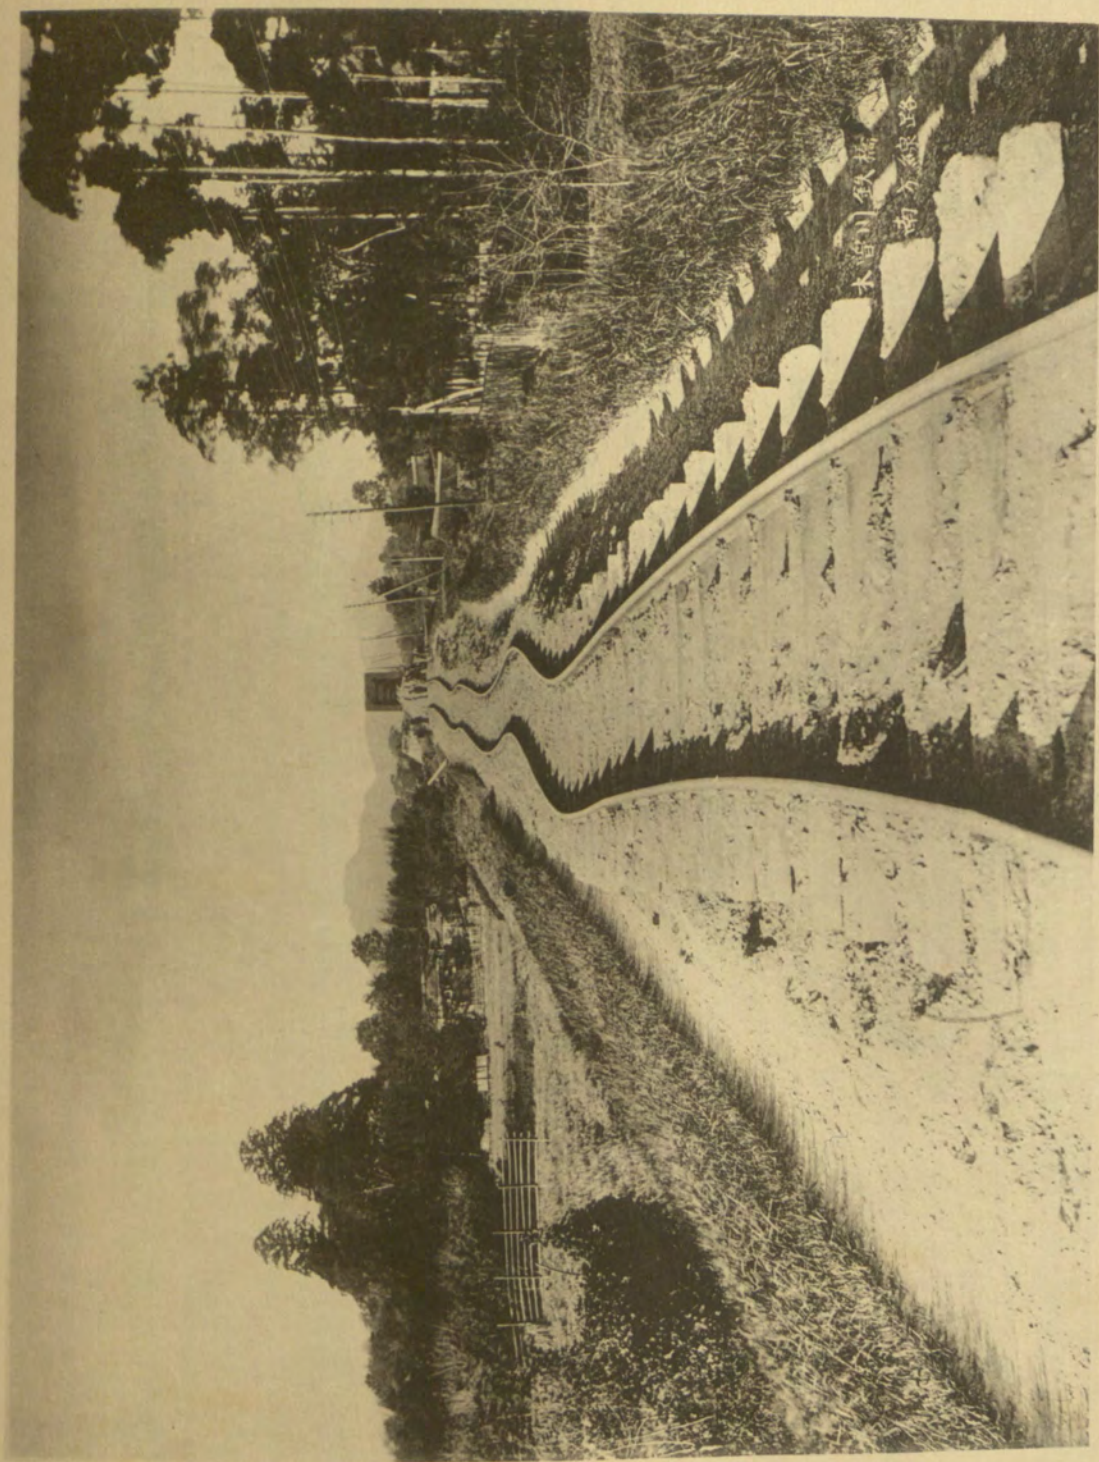
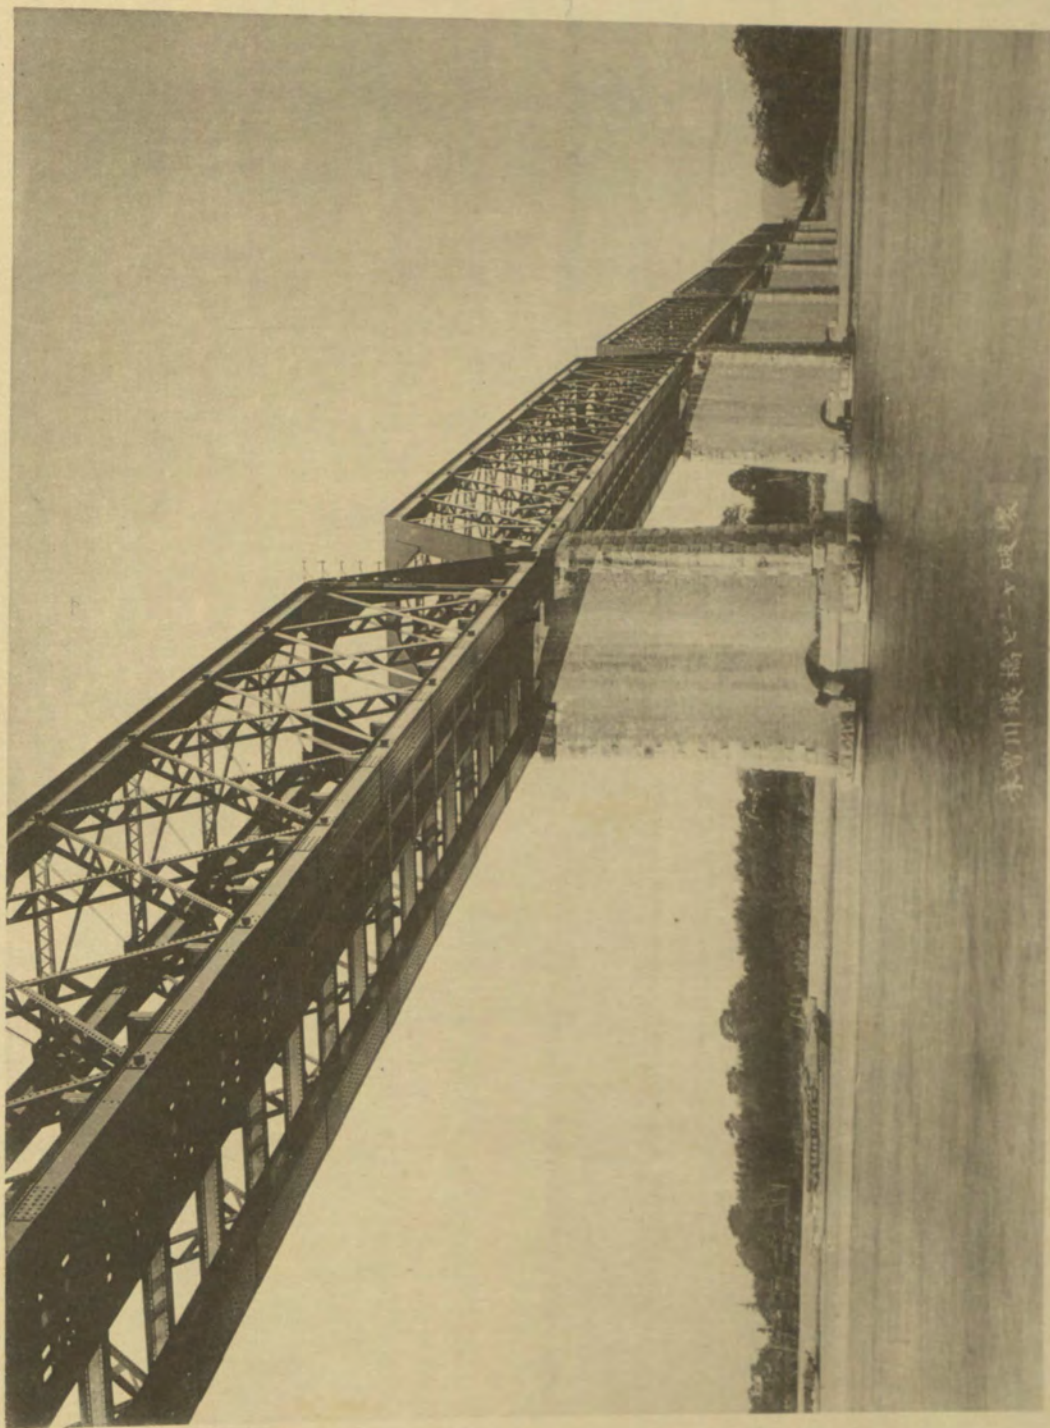
TWISTED RAILWAY LINE AND THE KISOGAWA BRIDGE.

A more important feature is however the serpent-like bending of the line. Not only have the metals been deflected but the embankment has suffered a parallel deformation. It seems as if the country here,—and similar appearances are presented at other places,—had been subjected to a permanent longitudinal compression. At each of these bends, although not shewn in the present picture, to the right and left of the line, there is generally a slight depression in the general contour of the country, which possibly may mark the line of an ancient watercourse, in which we may imagine, that the materials are softer than elsewhere. The track crossing such depressions would be crossing lines of weakness, where yielding would be relatively easy, or along which a greater quantity of motion may have passed.

The Kisogawa Bridge which is shewn in the lower picture is 1800 feet in length, and ranks among the finest on this section of the Railway. The girders which are 200 feet in length are supported on brick piers

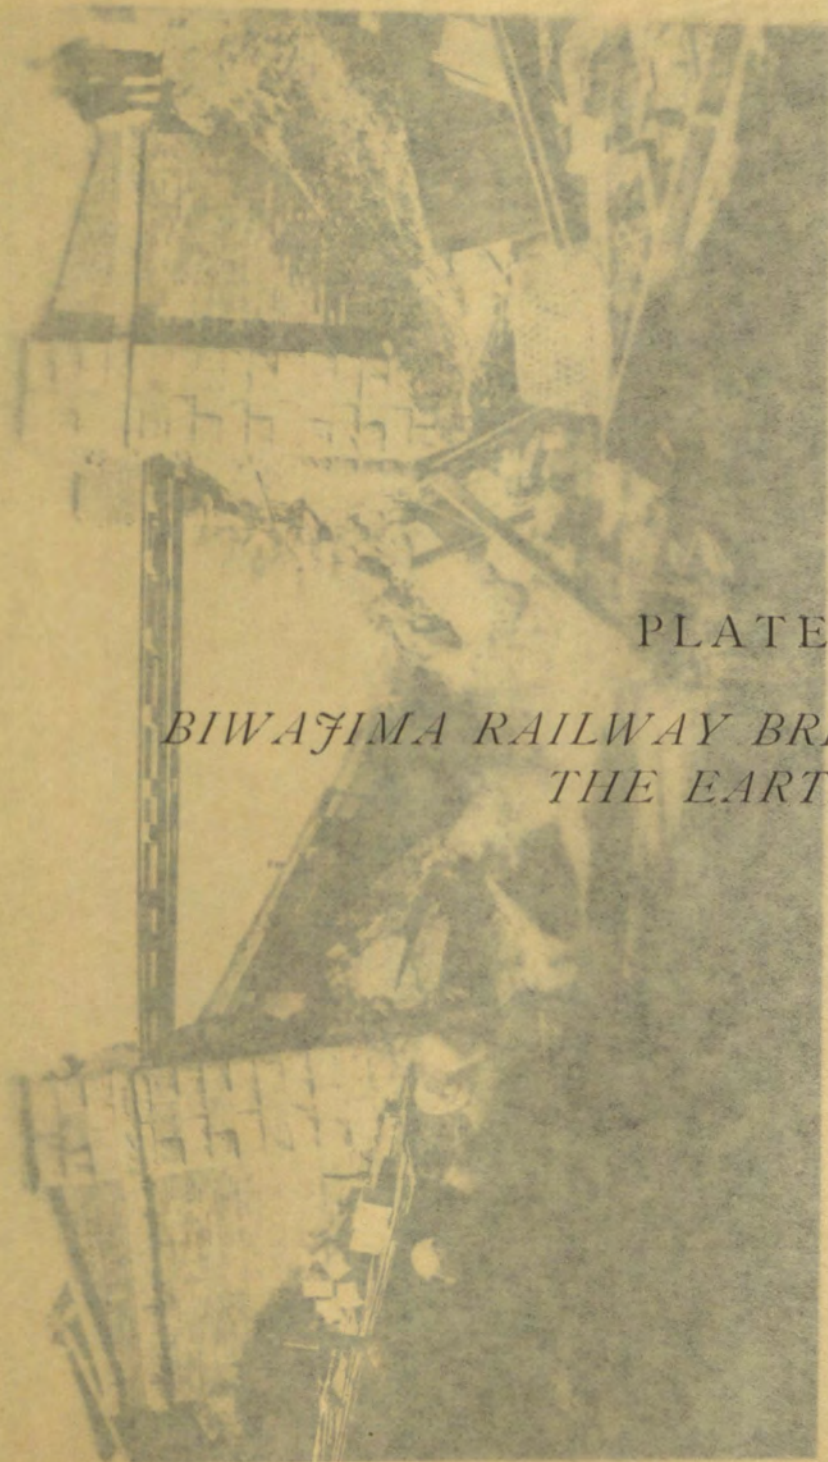
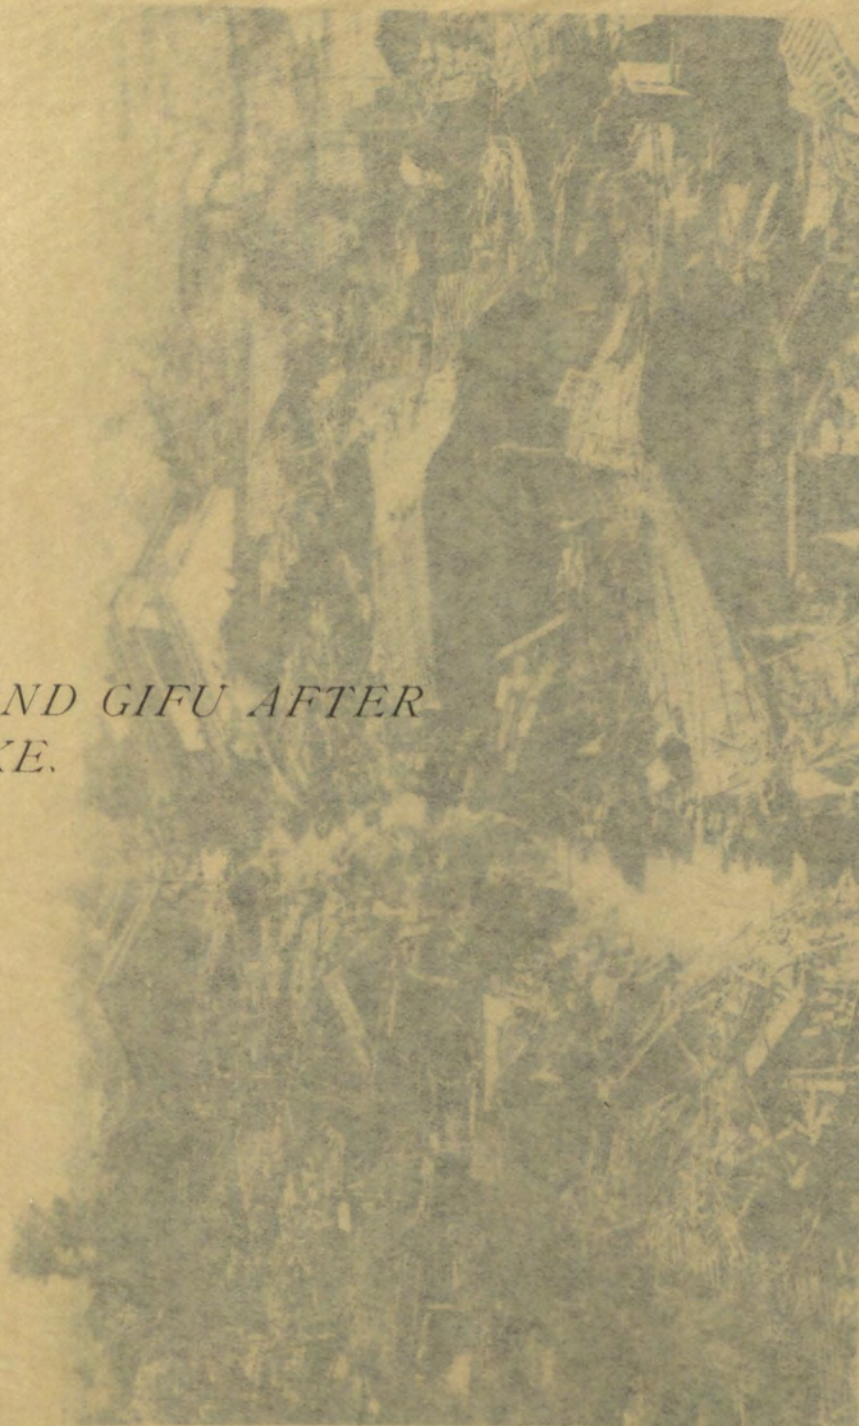
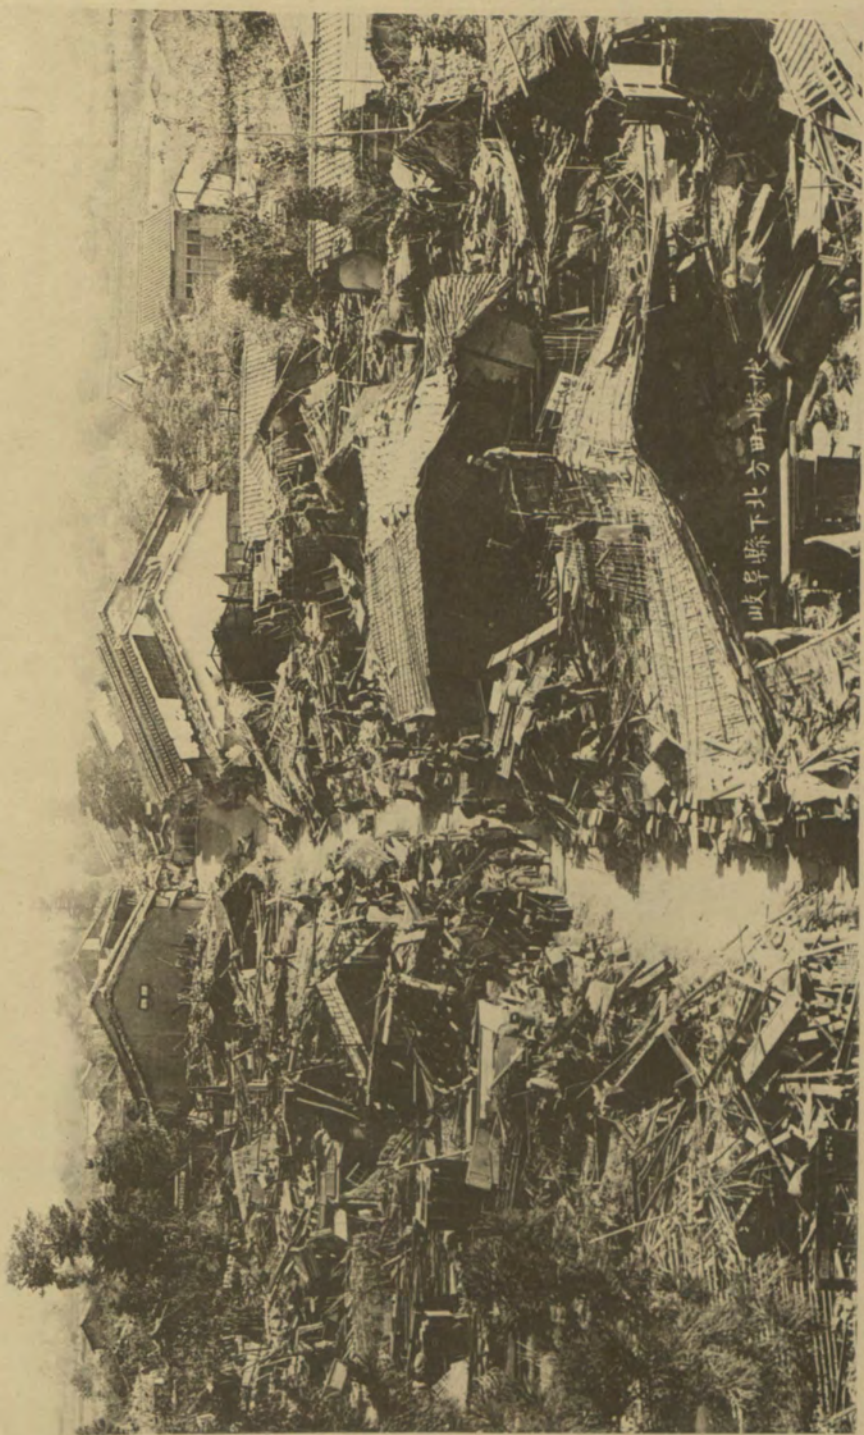
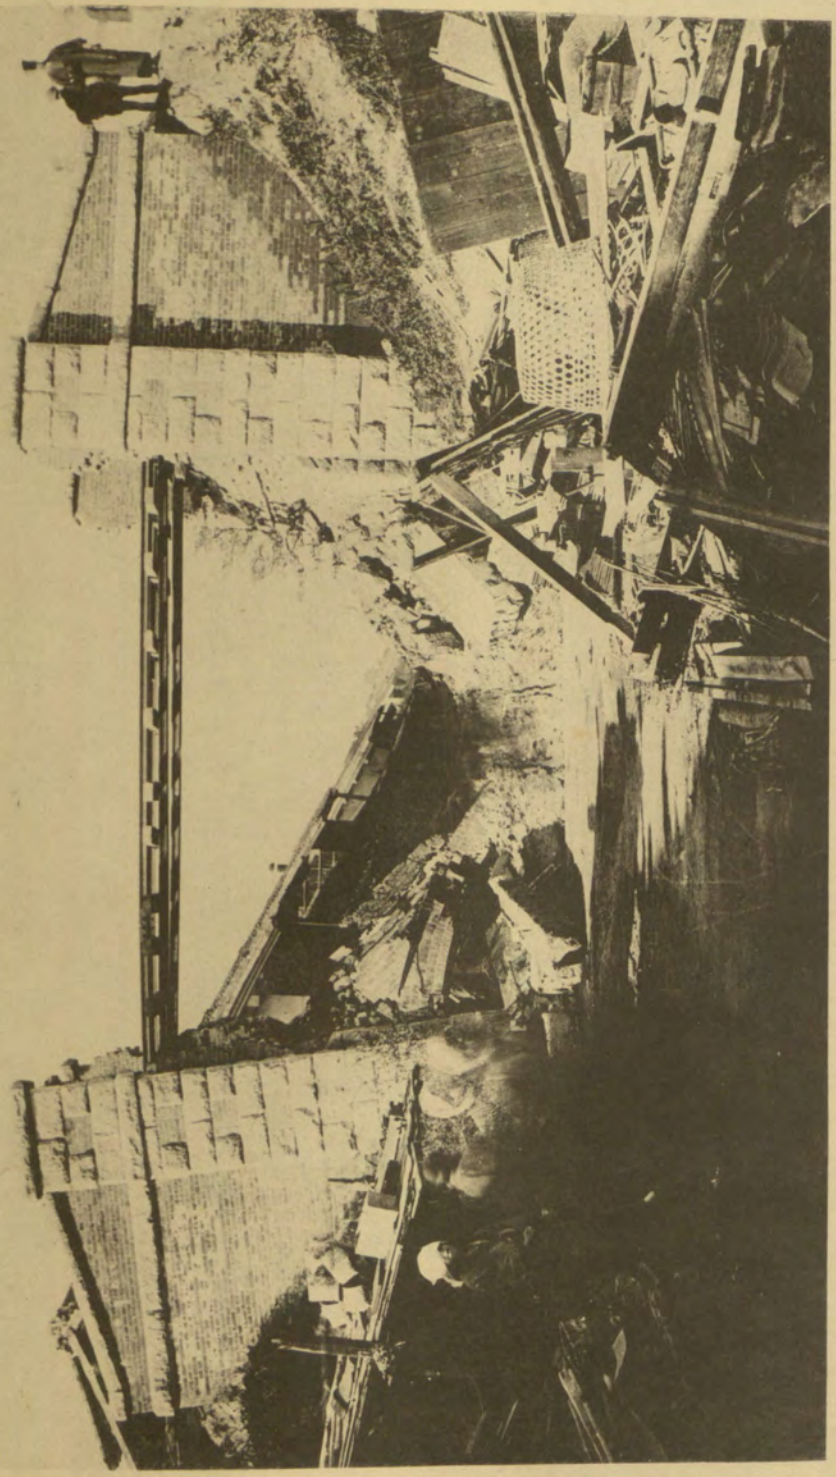
PLATE XII.

One explanation of this disaster is that the embankments to the right and left first gave way and the thrust, due to the weight of the arch as it cracked and sank, acted like a toggle-joint, forcing the abutments backwards.

Whatever the cause may have been, it illustrates the unsuitability of arches to horizontal disturbances, and assists us in understanding the reason why, in several Earthquake countries, ordinary archwork is prohibited.

which are from 15 to 30 feet in height and have a cross-section of 20 feet by 10 feet. Each of these rises from two wells which are arched together at the water-line. It is through this arch, which it must be observed is the lowest part of the piers, where fracture has taken place.

The fracture has therefore been across or through the narrowest dimension of the columns. The lateral shifting of the foundations by which the distances between the piers have been reduced, has been the result of a permanent compression, which had the bridge been represented by a line across the river bed, would have been contorted into one or more snake like bends.
